Use Attainability Analysis

WBID 1386 South Dry Sac River

Submitted by
SES, Inc.

To
Missouri Department of Natural Resources
Water Protection Program

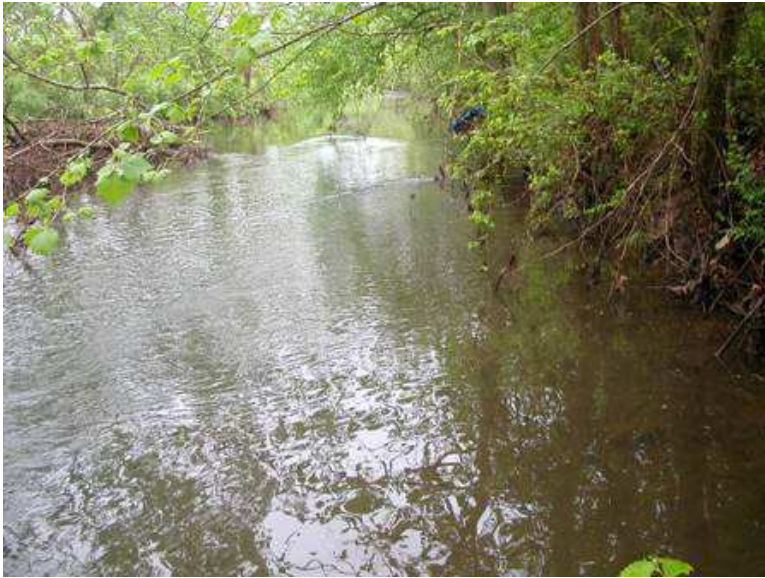
Site# 1 Photo ID# 9, Upstream

WBID # 1386 **Site #** 1
Mark # 5 **Dissolved Oxygen (ppm)** 8.6
Upstream Views Physical Dimensions: Is there any water present at this view? yes

If so, is there an obvious current? yes

% of Channel Feature				
Riffle	10				
Run	10				
Pool	80

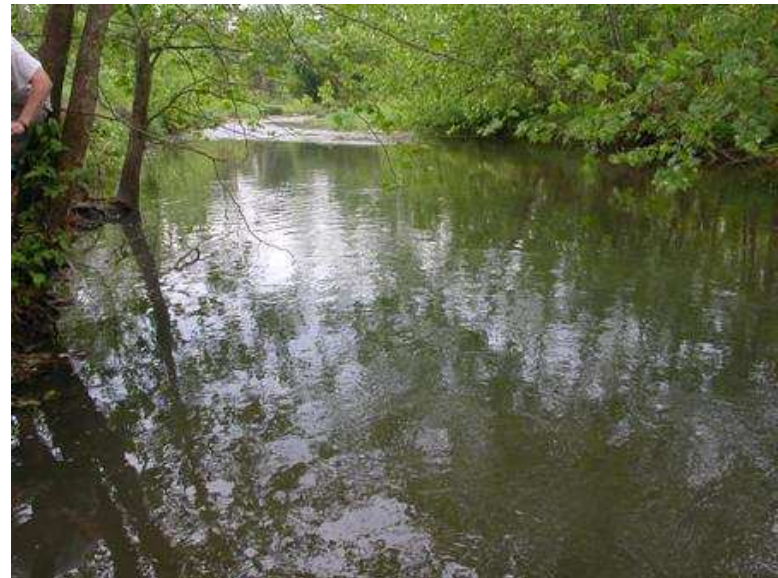
Site# 1 Photo ID# 8, Downstream

Downstream View's Physical Dimensions: Is there any water present at this view? yes

If so, is there an obvious current? yes

% Cobble	% Gravel	% Sand	% Silt
40	55	0	5
% Mud/Clay	% Bedrock		
0	0

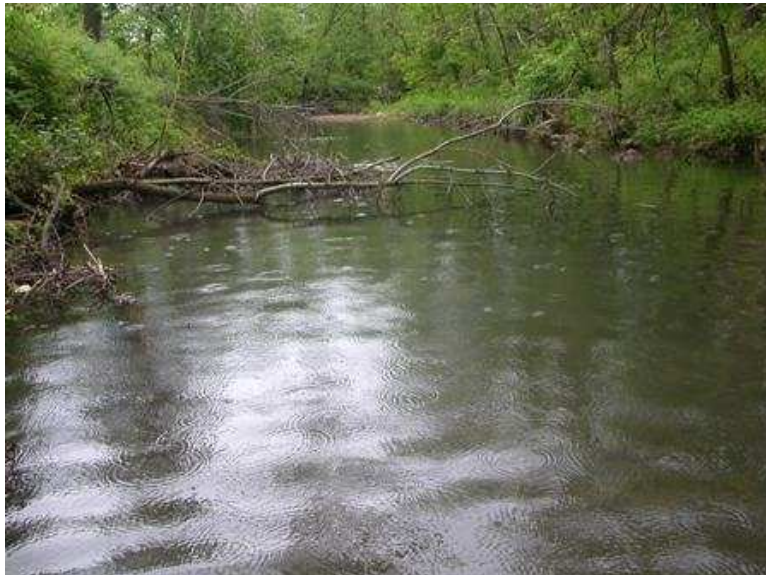
Site# 2 Photo ID# 11, Upstream

WBID # 1386 **Site #** 2
Mark # 6 **Dissolved Oxygen (ppm)** 8.4
Upstream Views Physical Dimensions: Is there any water present at this view? yes

If so, is there an obvious current? yes

% of Channel Feature				
Riffle	27				
Run	0				
Pool	73

Algae on rocks. No floating algae. Vegetation along bank.

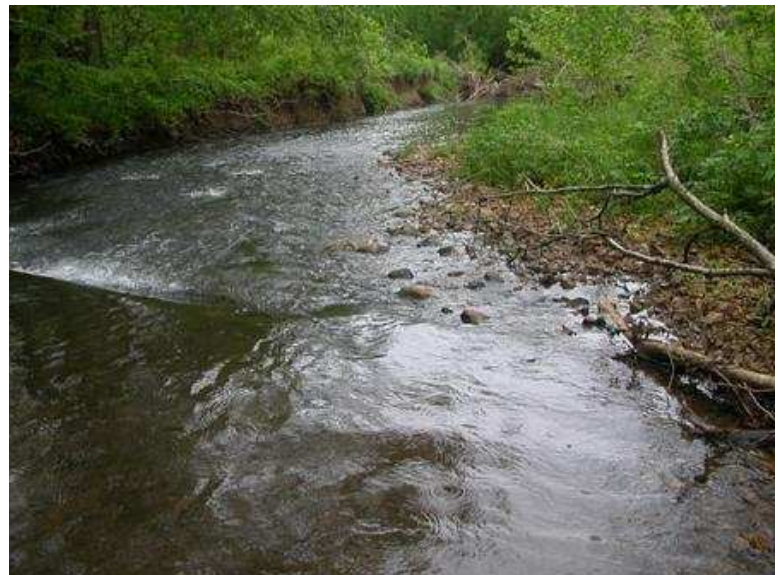
Site# 2 Photo ID# 10, Downstream

Downstream View's Physical Dimensions: Is there any water present at this view? yes

If so, is there an obvious current? yes

% Cobble	% Gravel	% Sand	% Silt
52	38	0	0
% Mud/Clay	% Bedrock		
0	10

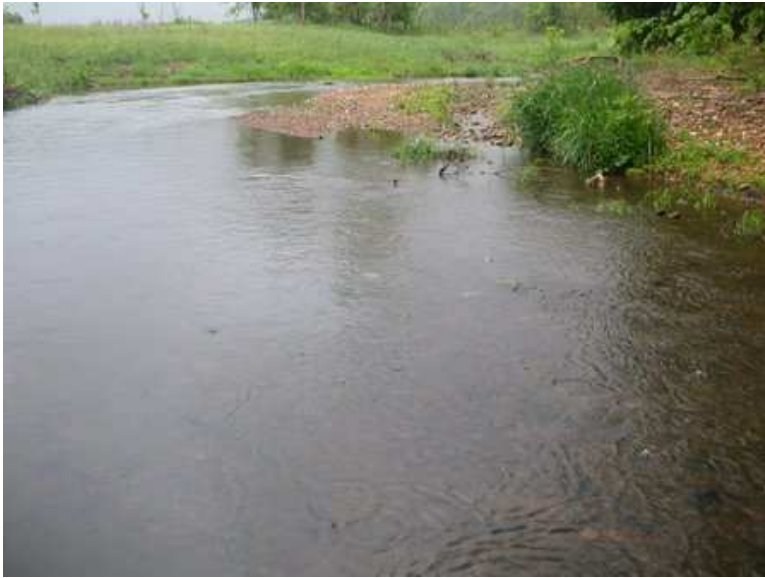
Site# 3 Photo ID# 12, Upstream

WBID # 1386 **Site #** 3
Mark # 7 **Dissolved Oxygen (ppm)** 8.7
Upstream Views Physical Dimensions: Is there any water present at this view? yes

% of Channel Feature				
Riffle	0				
Run	0				
Pool	100

Algae on rocks. Vegetation along banks.

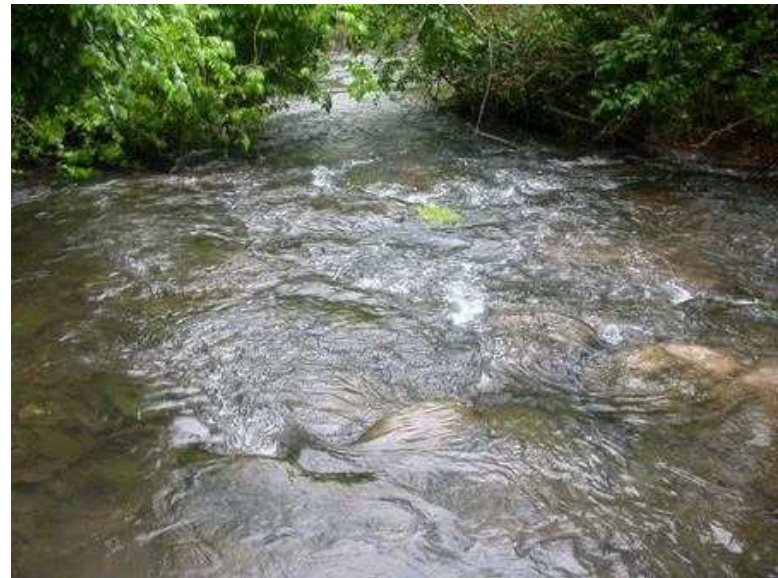
Site# 3 Photo ID# 13, Downstream

Downstream View's Physical Dimensions: Is there any water present at this view? yes

% Cobble	% Gravel	% Sand	% Silt
17	58	0	0
% Mud/Clay	% Bedrock		
0	25
